# Manhole Inspection Summary

Manhole # S47I\_\_047MH

Insp Date: **4/17/08 12:48 PM**

**Location** Address: **302 s maderia st**

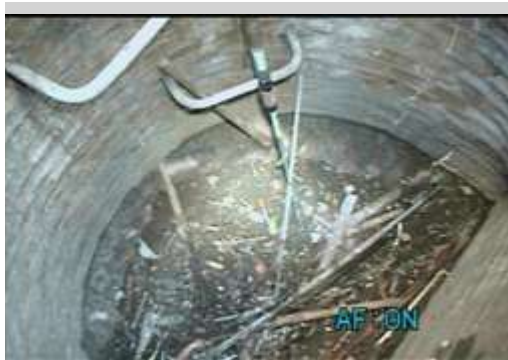
Defect 3

Condition: ☐ Sound ☐ Cracked ☐ Root Intrusion ☐ Deteriorated ☐ Leaks ☒ **Debris**

channel debris

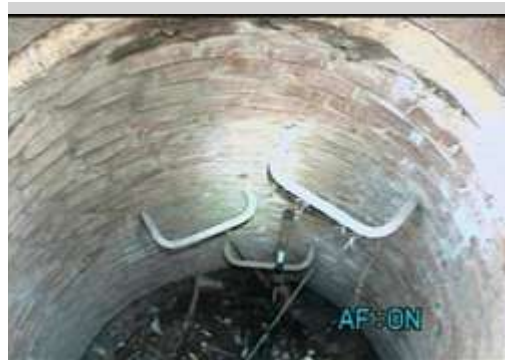
Defect 2

**Steps** Count: **3** Missing: **0** ☒ **Corroded**

corroded stairs

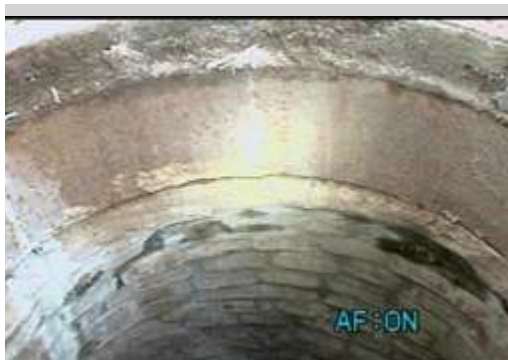
Defect 1

**Frame** Offset: **2** (in.) Condition: ☒ Sound ☐ Cracked ☐ Leaks

offset, frame adjustment
